Milwaukee Harbor Project

The Judy Company, Inc. used a fast setting sodium silicate-cement grout to rescue a crumbling breakwater in Milwaukee Harbor for the Corps of Engineers. The rehabilitation contract was valued at \$2.4 million, and was completed 45 days ahead of schedule. An alternative rehabilitation plan, to put new steel sheet piling on the structure, would have cost \$50 to \$60 million.

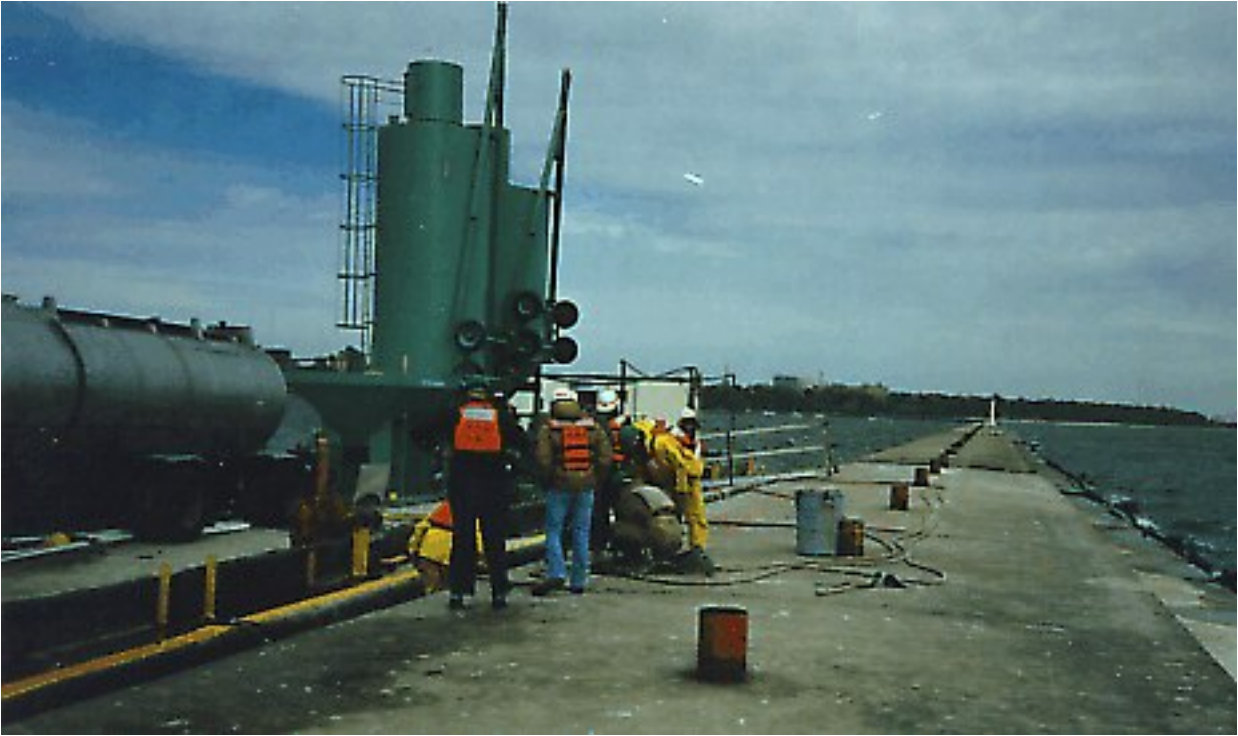
As a means of resupporting the concrete cap and relieving the stress on the steel sheet piling, a two-phase grouting concept was used. After drilling approximately 3200 holes in the concrete cap, 2600 cubic yards of quick-set grout was injected along the outer edge of the structure to form a barrier wall. The quick-set grout was formed by the combination of a sodium silicate solution and a cement solution, which when mixed in the proper proportions became a solid in less than one minute. The quick-set barrier walls served to confine the second type of grout, a sand/cement grout, of which 9,250 cubic yards were injected into the center of the structure to fill the remaining void.
