### Milwaukee Harbor Project

The Judy Company, Inc. used a fast setting sodium silicate-cement grout to rescue a crumbling breakwater in Milwaukee Harbor for the Corps of Engineers. The rehabilitation contract was valued at \$2.4 million, and was completed 45 days ahead of schedule. An alternative rehabilitation plan, to put new steel sheet piling on the structure, would have cost \$50 to \$60 million.

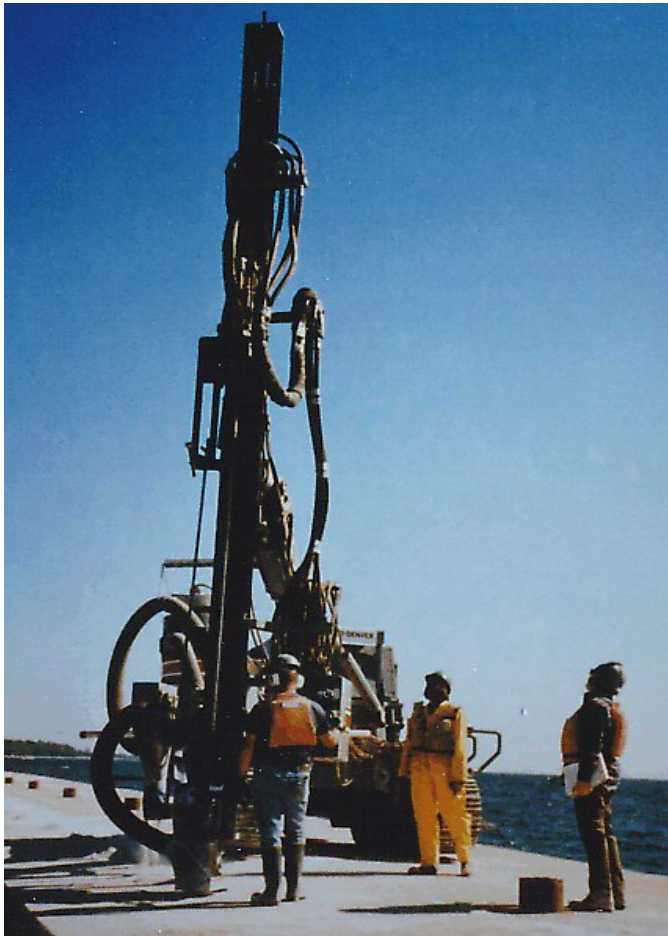
The North Detached Breakwater was rehabilitated using grouting as a unique means of repair. The existing structure consisted of stone filled timber cribs constructed in the 1890's, which were encased in steel sheet piling and capped with a concrete superstructure in the 1950's. Over the years, the stone fill within the timber cribs had settled, creating a 3 to 4 foot void between the bottom of the concrete cap and the top of the stone fill. This void condition resulted in settlement of the concrete superstructure and subsequent failure of the steel sheet piling.

As a means of resupporting the concrete cap and relieving the stress on the steel sheet piling, a two-phase grouting concept was used. After drilling approximately 3200 holes in the concrete cap, 2600 cubic yards of quick-set grout was injected along the outer edge of the structure to form a barrier wall. The quick-set grout was formed by the combination of a sodium silicate solution and a cement solution, which when mixed in the proper proportions became a solid in less than one minute. The quick-set barrier walls served to confine the second type of grout, a sand/cement grout, of which 9,250 cubic yards were injected into the center of the structure to fill the remaining void.
